2024 CCLEP Clean Energy Home Tour
Chris O'Brien and Jane Alexander
97 Old Ski Hill Road

Home description

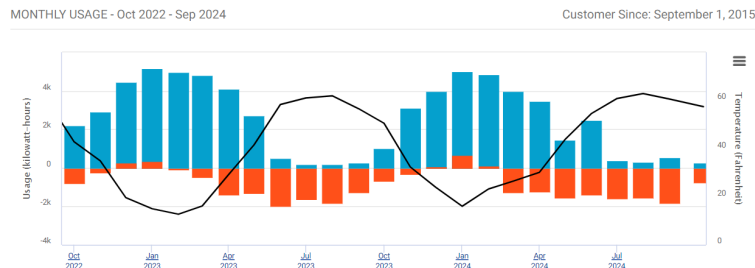
The chart below shows the energy consumption (net of PV generation) for the past two years. The blue bars represent the consumption of electricity for heating, which is approximately 85% of our total electricity consumption. The red bars represent the net electricity generation and non-heating consumption. Total consumption varies significantly by temperature, ranges roughly from 30,000 to 40,000 kWh per year.

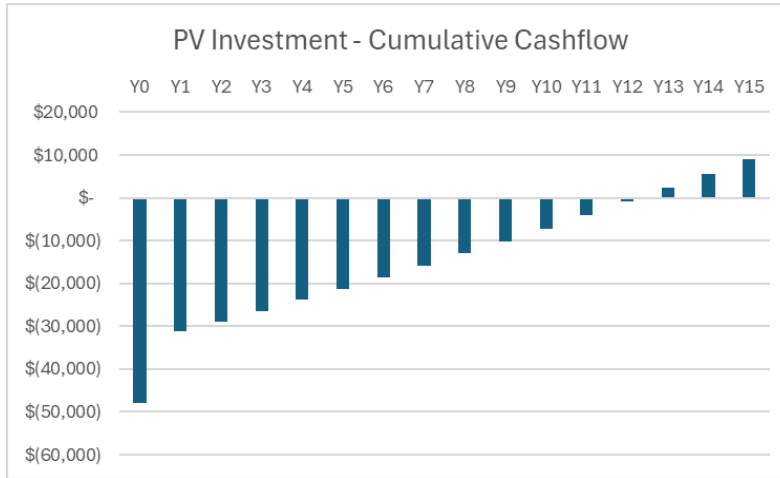
Solar PV Investment Analysis

The installed cost of our system in 2019 was approximately \$48k. We received a 30% Federal tax credit to offset a portion of the cost. Based on forecast production and forecast electric rates (assume 3% increase per year) the payback for our system is expected to be approximately 12 years and the Internal Rate of Return (IRR) over the expected 30 year life of the PV system is approximately 8%.

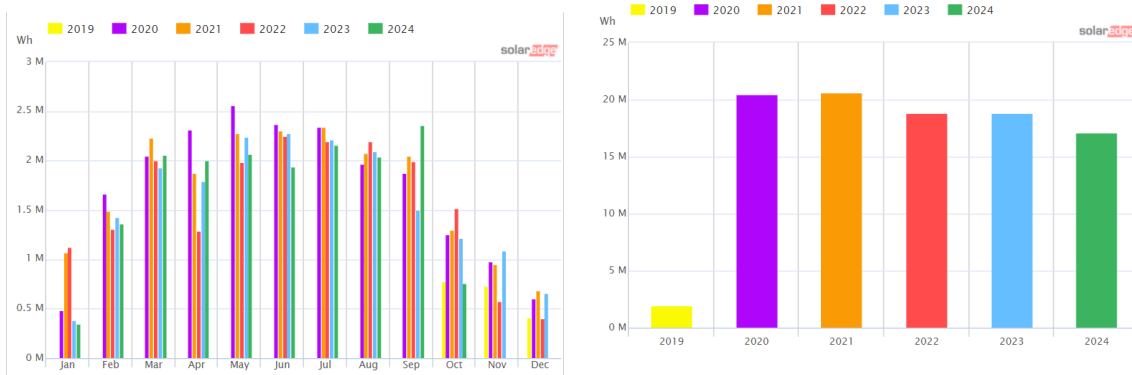
Solar Generation

Solar generation history is shown in the charts below. Annual generation has been roughly 19,000 to 20,000 kWh per year, which is approximately 1,250 kWh per kWdc of PV capacity and approximately 60% of our total electricity usage.
